# Manhole Inspection Summary

Manhole # S35AA\_009MH

**Inspection** ☐ Is Incomplete Rating: **3) Fair**

**Location** Address: **208 read st**

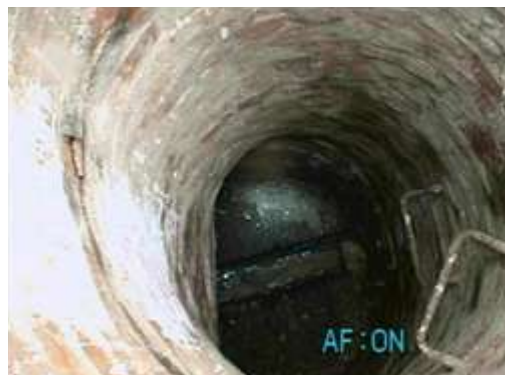
Top View

shelf blocks view of 12 o'clock and 6 o'clock channel. Image is oriented correctly, with pipe out @ 12.

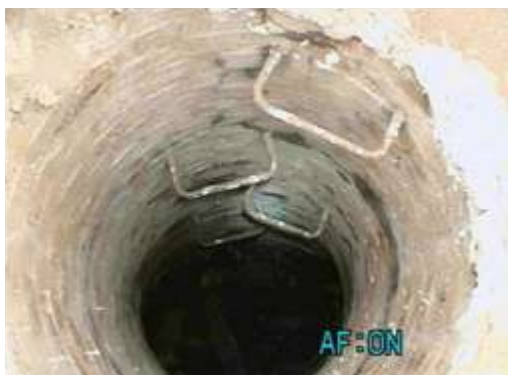
Defect 2

Condition: ☐ Sound ☐ Cracked ☐ Root Intrusion ☐ Loose Brick ☒ **Deteriorated**

Count: **7** Missing: **3** ☒ **Corroded**

chimney cond deteriorated, corr steps

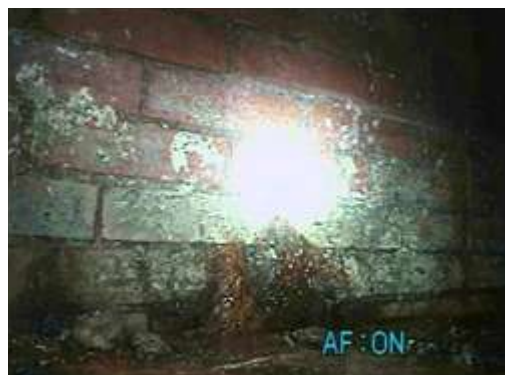
Defect 1

Infiltration: ☐ None ☐ Joint ☐ Cracks ☐ Mortar ☐ Roots ☒ **Wall**

barrel flow wall

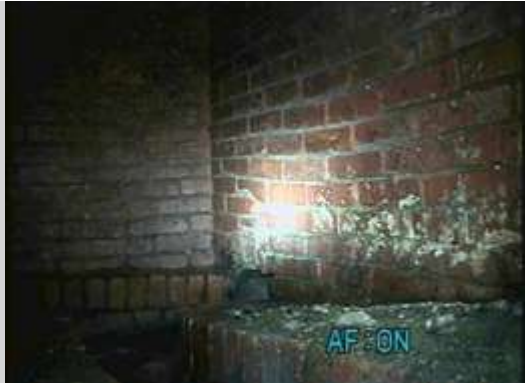
12 O'Clock Outflow

shelf prevents camera from moving closer to see inside pipe.

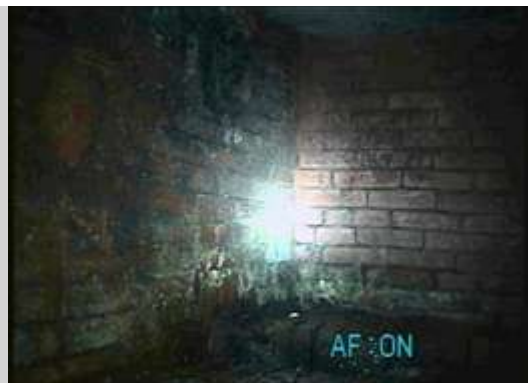
6 O'Clock Inflow

This is as close as the camera can get.
